REPORT ON VIBRATION MONITORING

**GRANGEGORMAN CAMPUS CENTRAL & EAST QUAD,
DUBLIN 7**

INTERIM VIBRATION REPORT 026-02: 29th September to 31st October 2019.

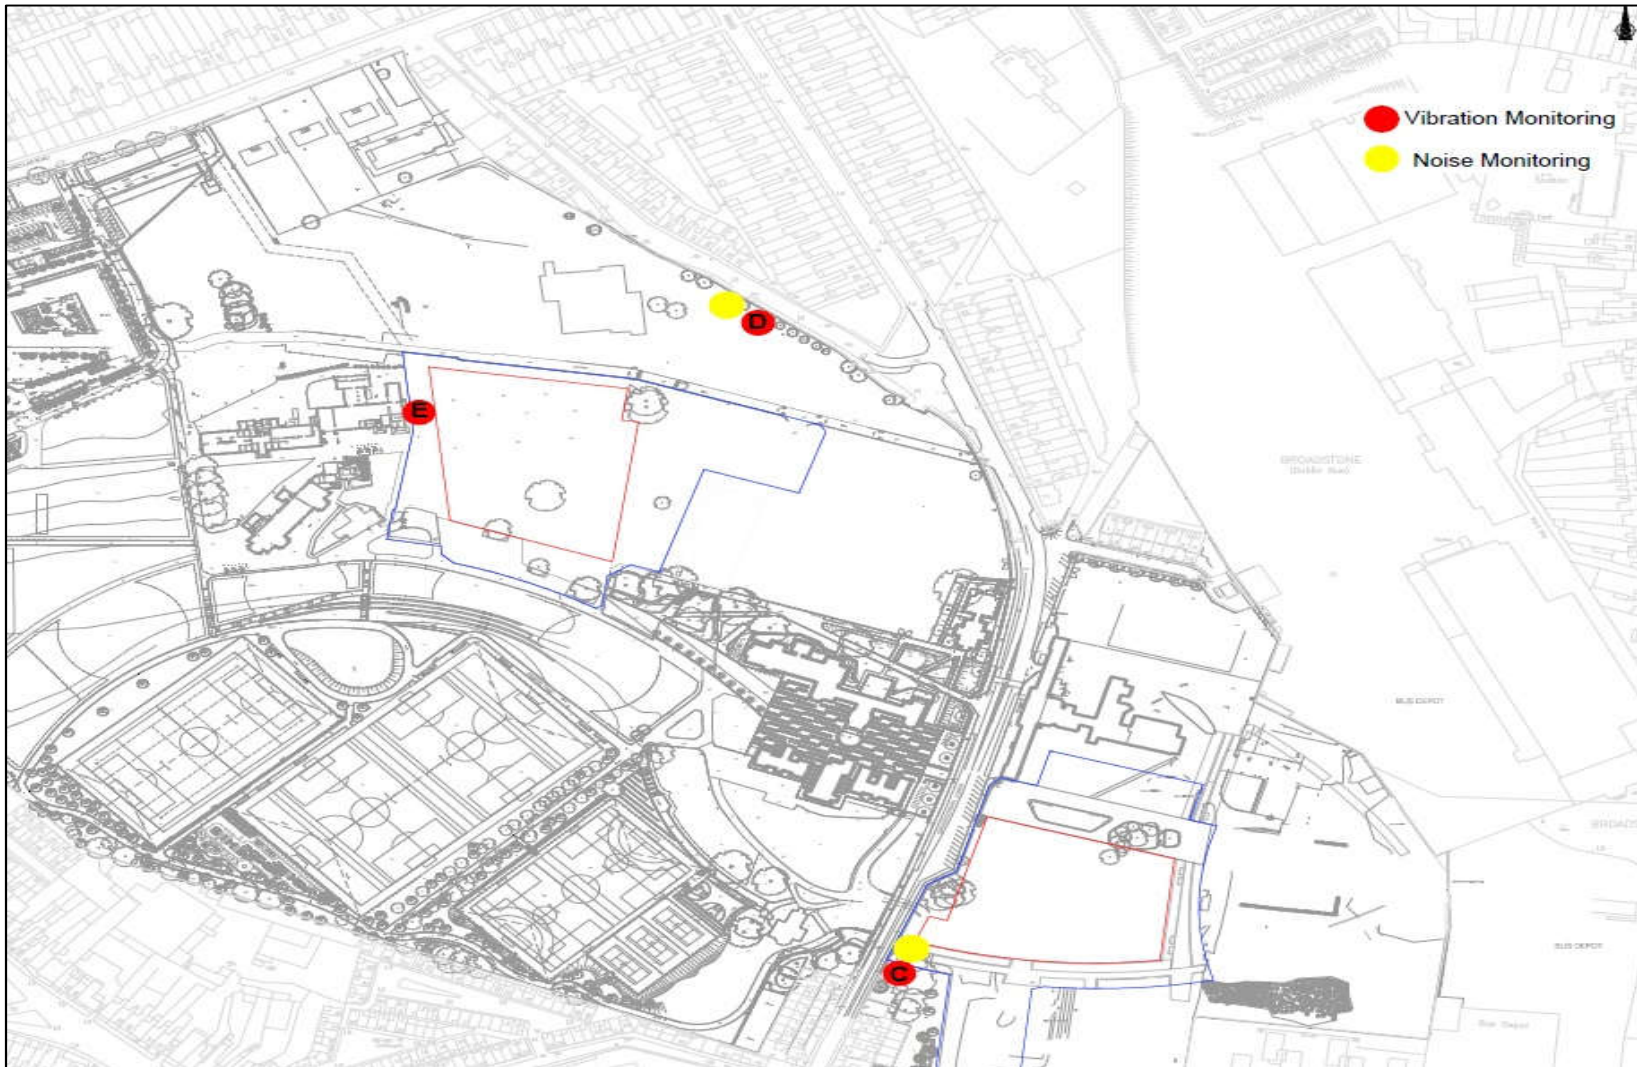
Figure 1: Vibration monitoring locations

Glenside Environmental were commissioned by Sisk FCC GG PPP Joint Venture, to conduct vibration monitoring during site development works at Grangegorman Campus Central & East Quad, Dublin 7. This report presents the results of vibration monitoring at 3 locations, C, D and E from 29th September to 31st October 2019. The locations are illustrated in Figure 1.

Vibration monitoring was carried out using 3 no. Vibrock vibration analysers with the units positioned at Locations, East Quad West Boundary Wall Location C, Grangegorman Upper Location D and Central Quad Location E, as shown in Figure 1.
