REPORT ON NOISE MONITORING

GRANGEGORMAN CAMPUS CENTRAL & EAST QUAD,

INTERIM NOISE REPORT 01-01: 8th to 23rd January 2018.

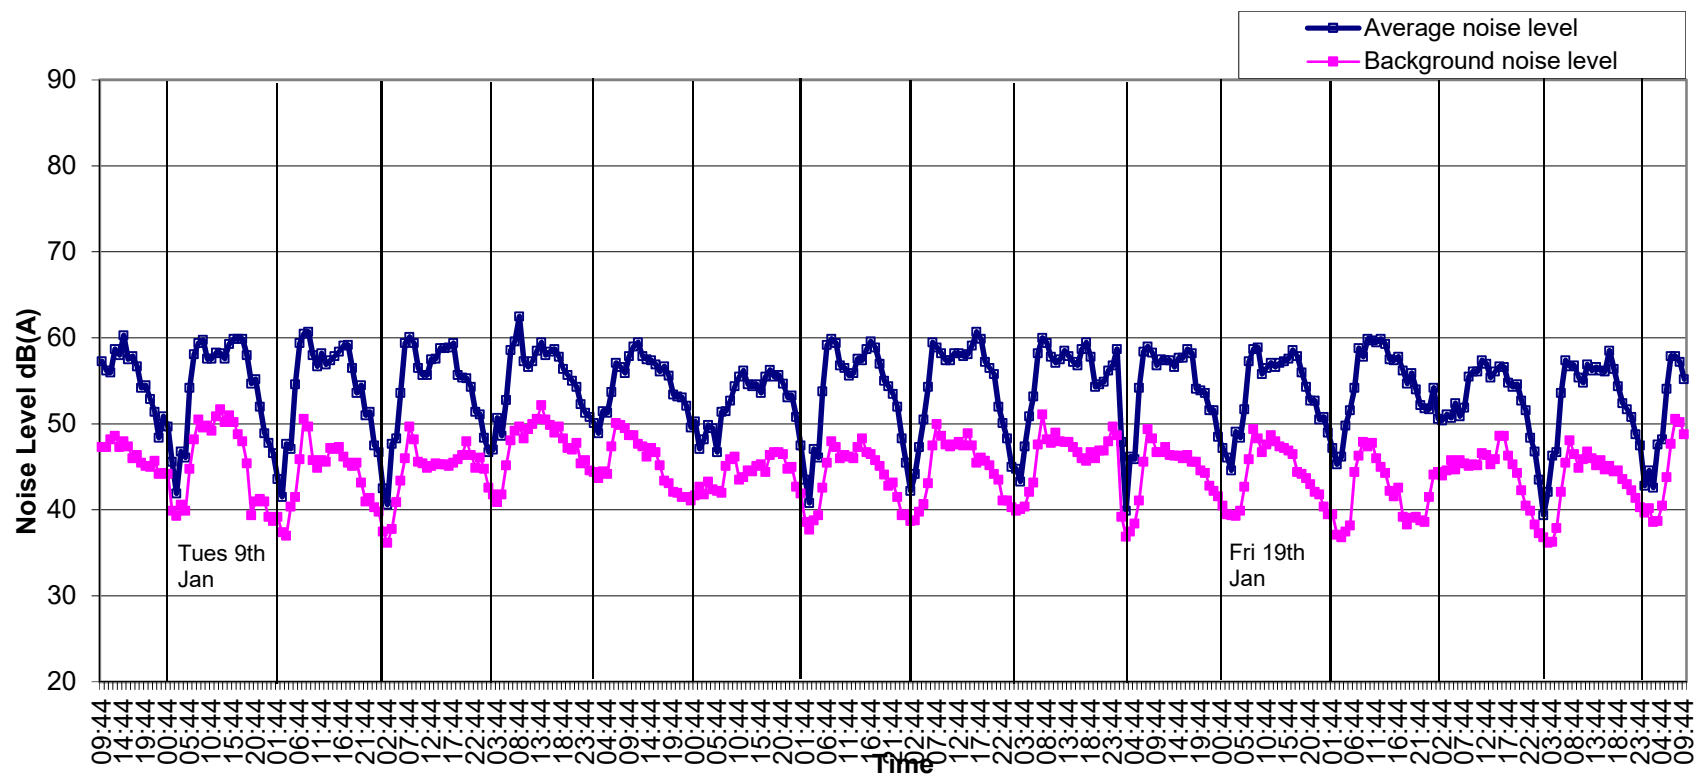
The graphs below specify the continuous noise levels at the monitoring locations A, B, during the reporting period 8th to 23rd January 2018. Regular local traffic dominates the noise levels at Locations A East Quad West Boundary Wall and Location B Grangegorman Upper adjacent the apartments at the east of the site.

Graph 1: Noise Levels at Location A East Quad West Boundary Wall from 8th to 23rd January 2018.

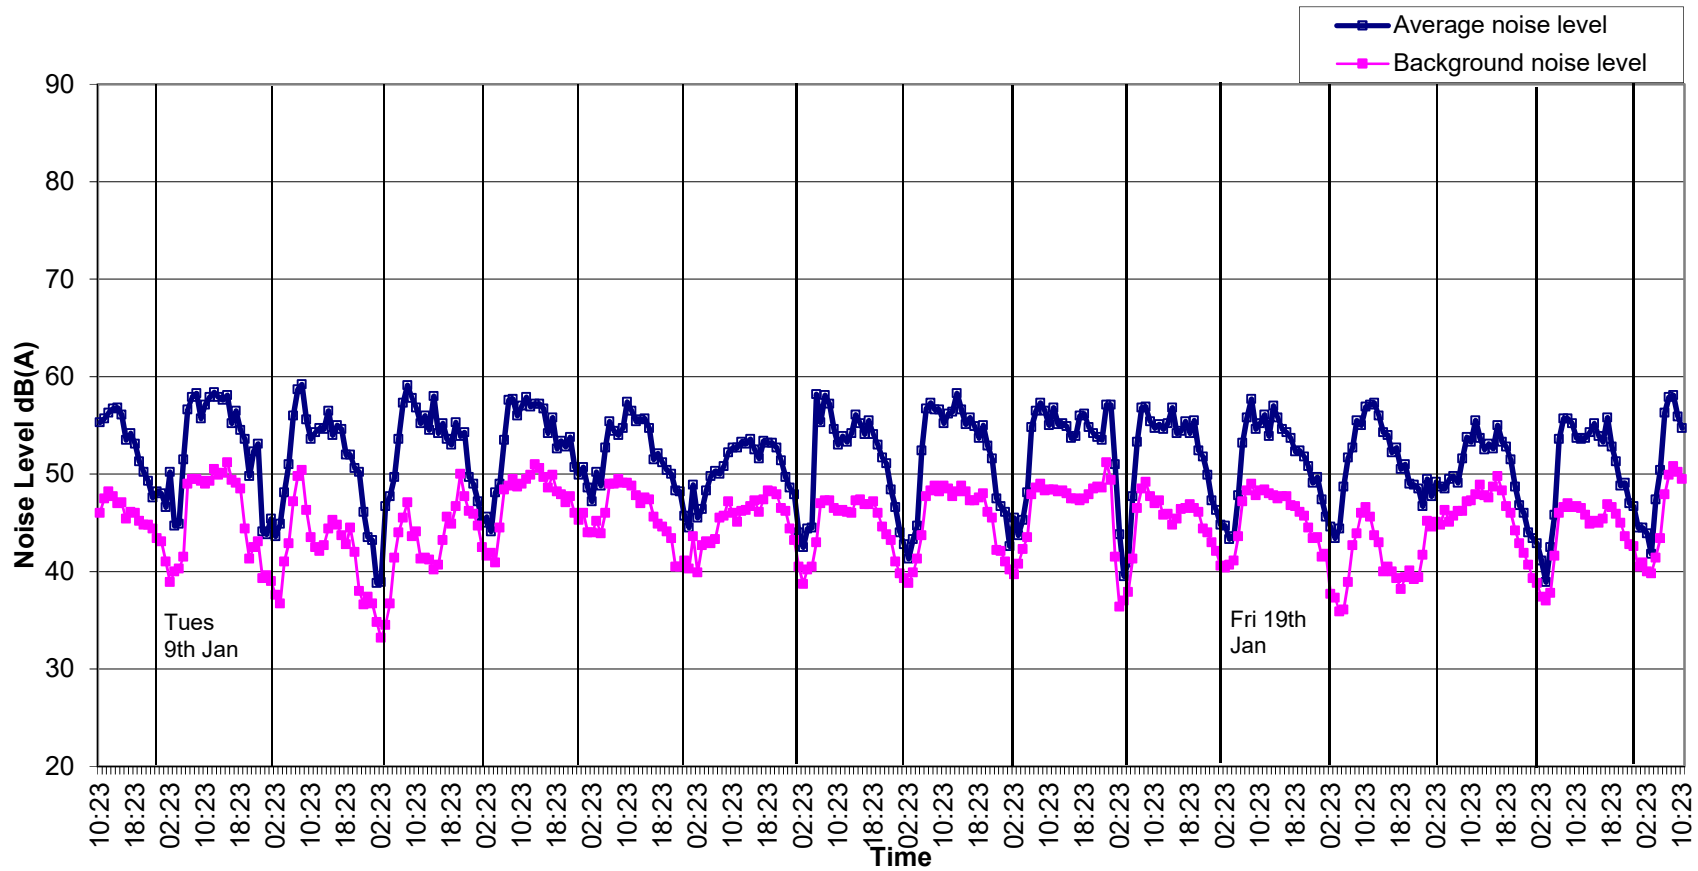
Graph 2: Noise Levels at Location B Grangegorman Upper from 8th to 23rd January 2018
