REPORT ON NOISE MONITORING

GRANGEGORMAN CAMPUS CENTRAL & EAST QUAD,

INTERIM NOISE REPORT 02-01: 23rd January to 21st February 2018.

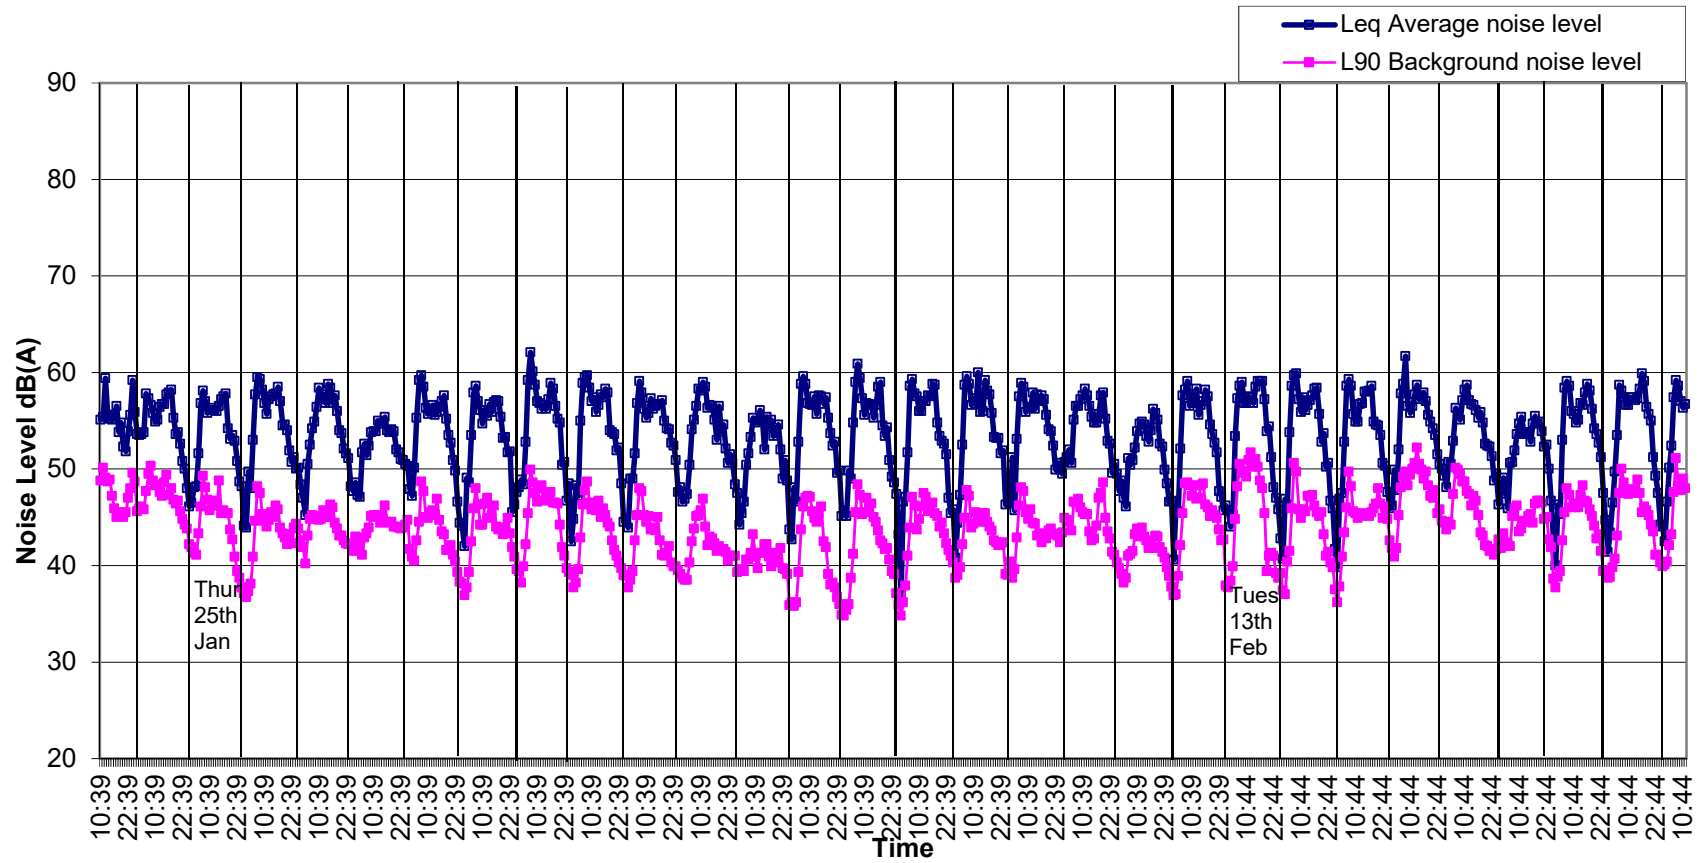
The graphs below specify the continuous noise levels at the monitoring locations A, B, during the reporting period 23rd January to 21st February 2018. Regular local traffic dominates the noise levels at Locations A East Quad West Boundary Wall and Location B Grangegorman Upper adjacent the apartments at the east of the site.

Graph 1: Noise Levels at Location A East Quad West Boundary Wall from 23rd January to 21st February 2018.

Results of the noise monitoring are presented in Graphs 1 to 2 and the location of the monitoring positions are shown in Figure 1.

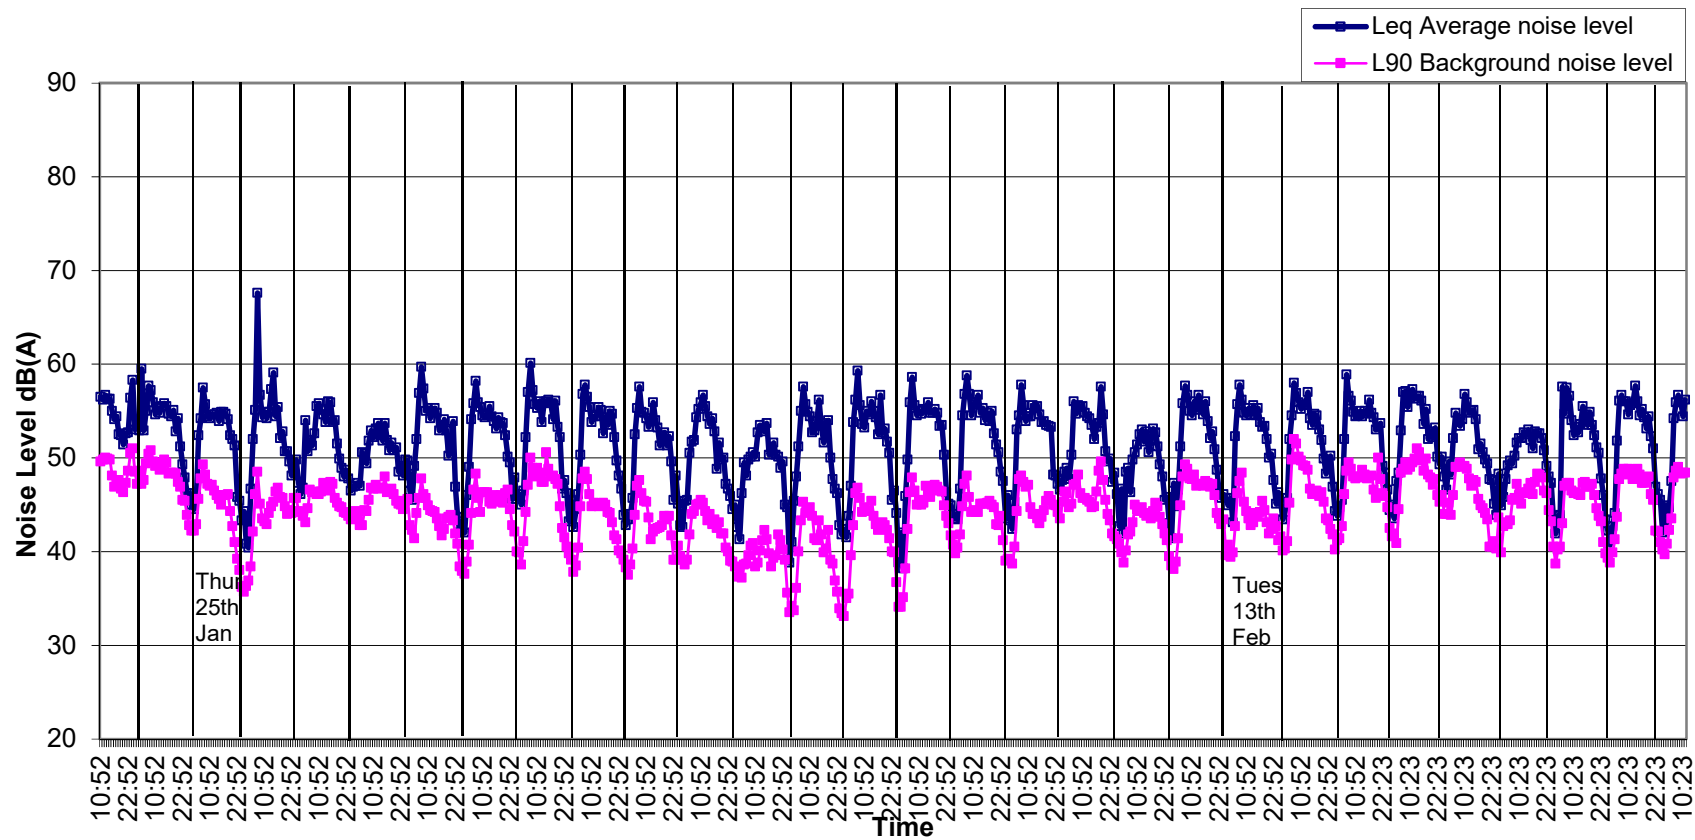
Graph 2: Noise Levels at Location B Grangegorman Upper from 23rd January to 21st February 2018
