REPORT ON NOISE MONITORING

GRANGEGORMAN CAMPUS CENTRAL & EAST QUAD,

INTERIM NOISE REPORT 05-01: 23rd March to 10th April 2018.

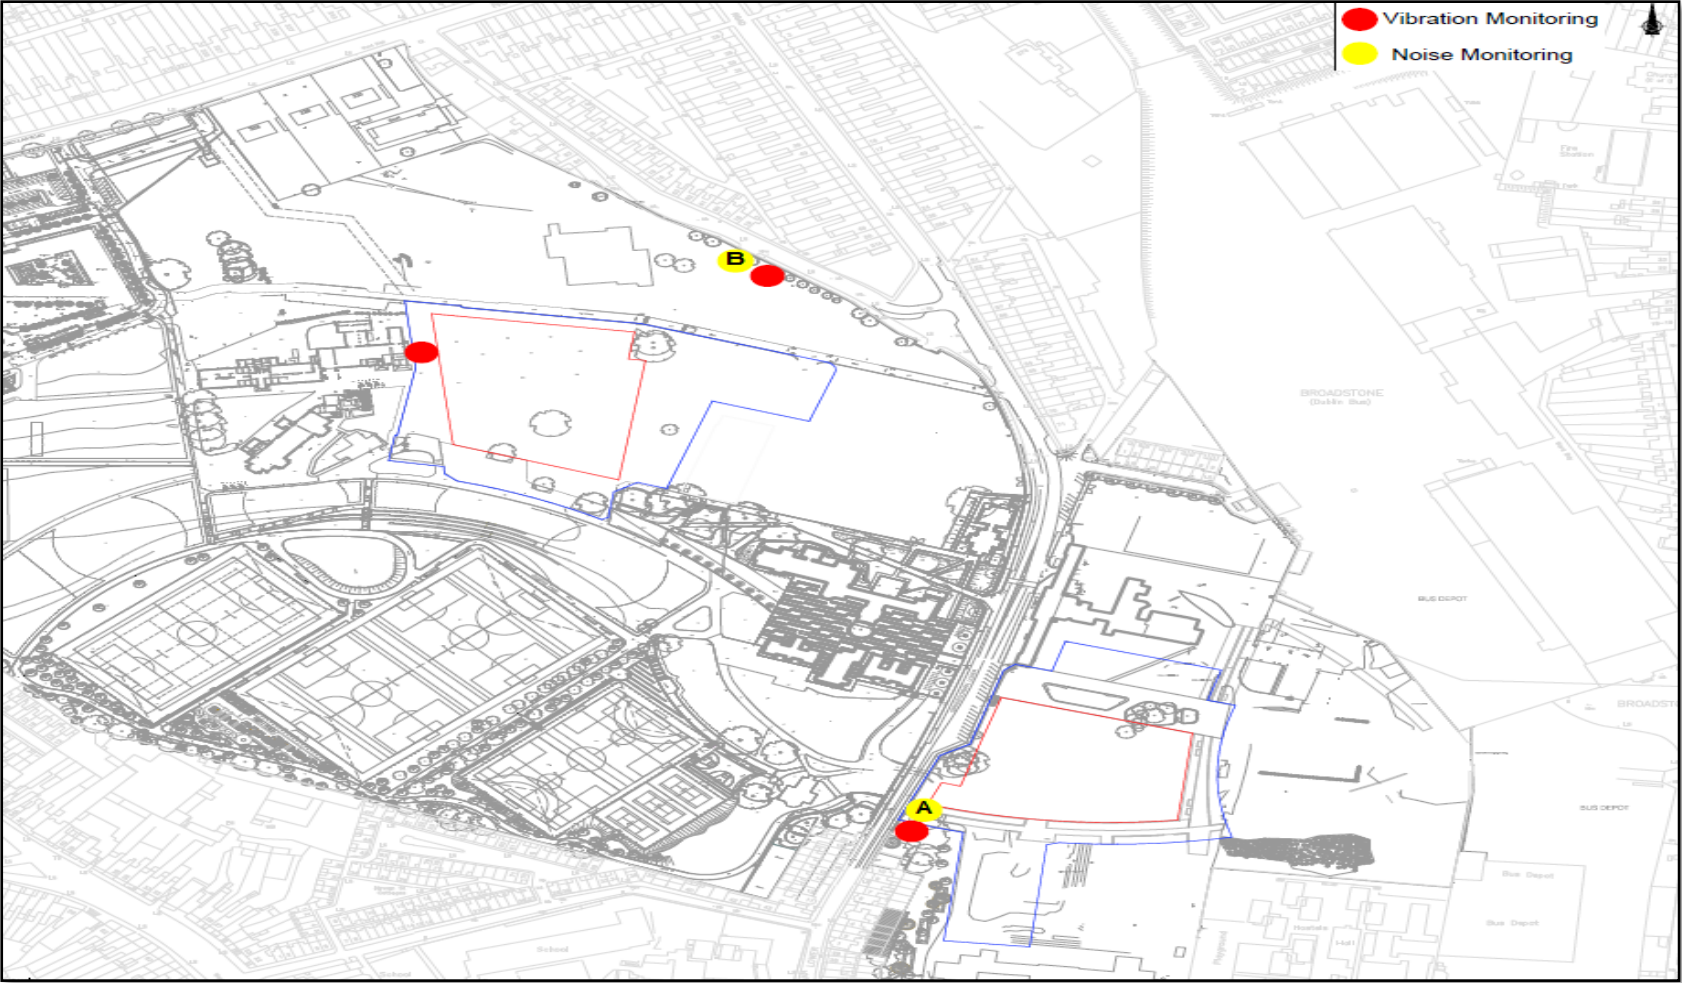
Figure 1: Noise Monitoring Locations

Glenside Environmental were commissioned by Sisk FCC GG PPP Joint Venture, to conduct noise monitoring during site development works at Grangegorman Campus Central & East Quad Dublin 7. This report presents the results of noise monitoring at 2 locations; Location A East Quad West Boundary Wall and Location B Grangegorman Upper, from 23rd March to 10th April 2018. The locations are illustrated on Figure 1.

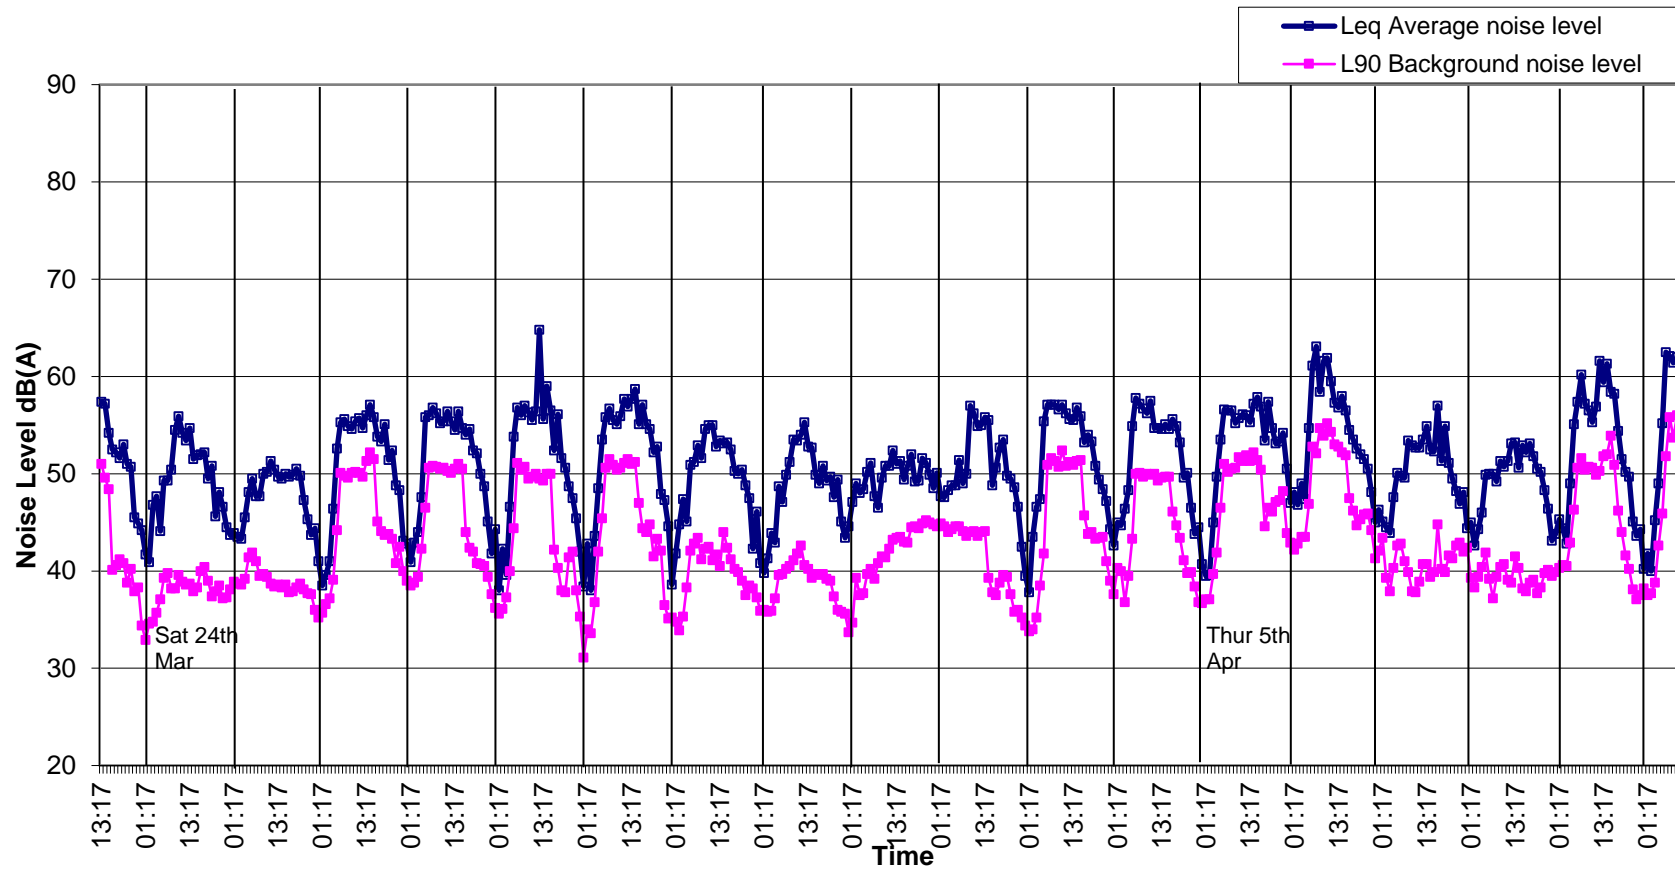
The graphs below specify the continuous noise levels at the monitoring locations A, B, during the reporting period 23rd March to 10th April 2018. Regular local traffic dominates the noise levels at Locations A at the East Quad West Boundary Wall and Location B at Grangegorman Upper adjacent the apartments at the east of the site.

Graph 1: Noise Levels at Location A East Quad West Boundary Wall from 23rd March to 10th April 2018.

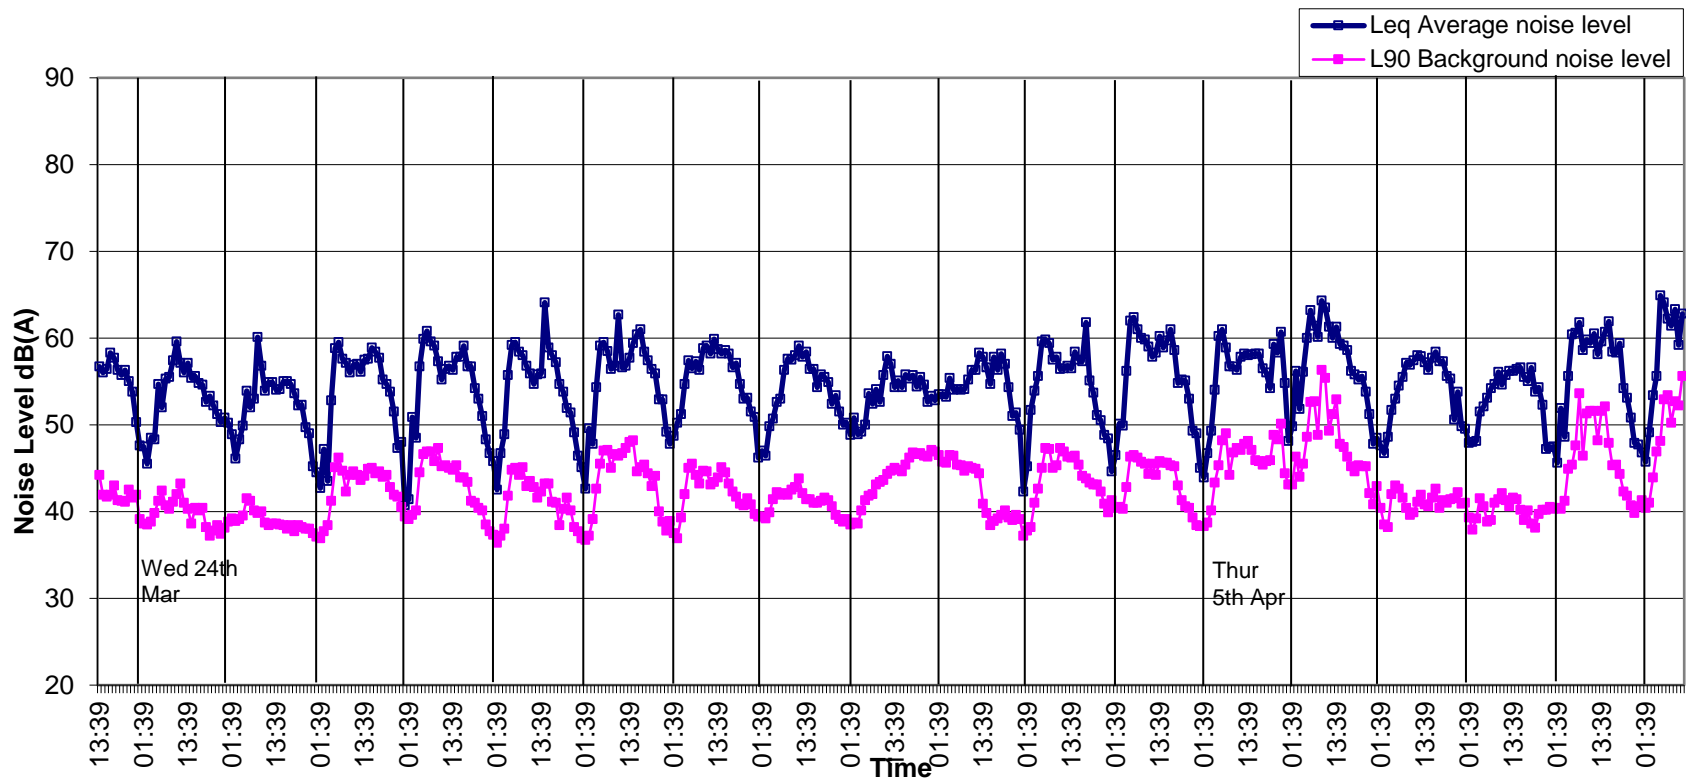
Graph 2: Noise Levels at Location B Grangegorman Upper from 23rd March to 10th April 2018
