REPORT ON DUST MONITORING

GRANGEGORMAN CAMPUS CENTRAL & EAST QUAD,

INTERIM DUST MONITORING REPORT 22-03

31st May to 28th June 2019

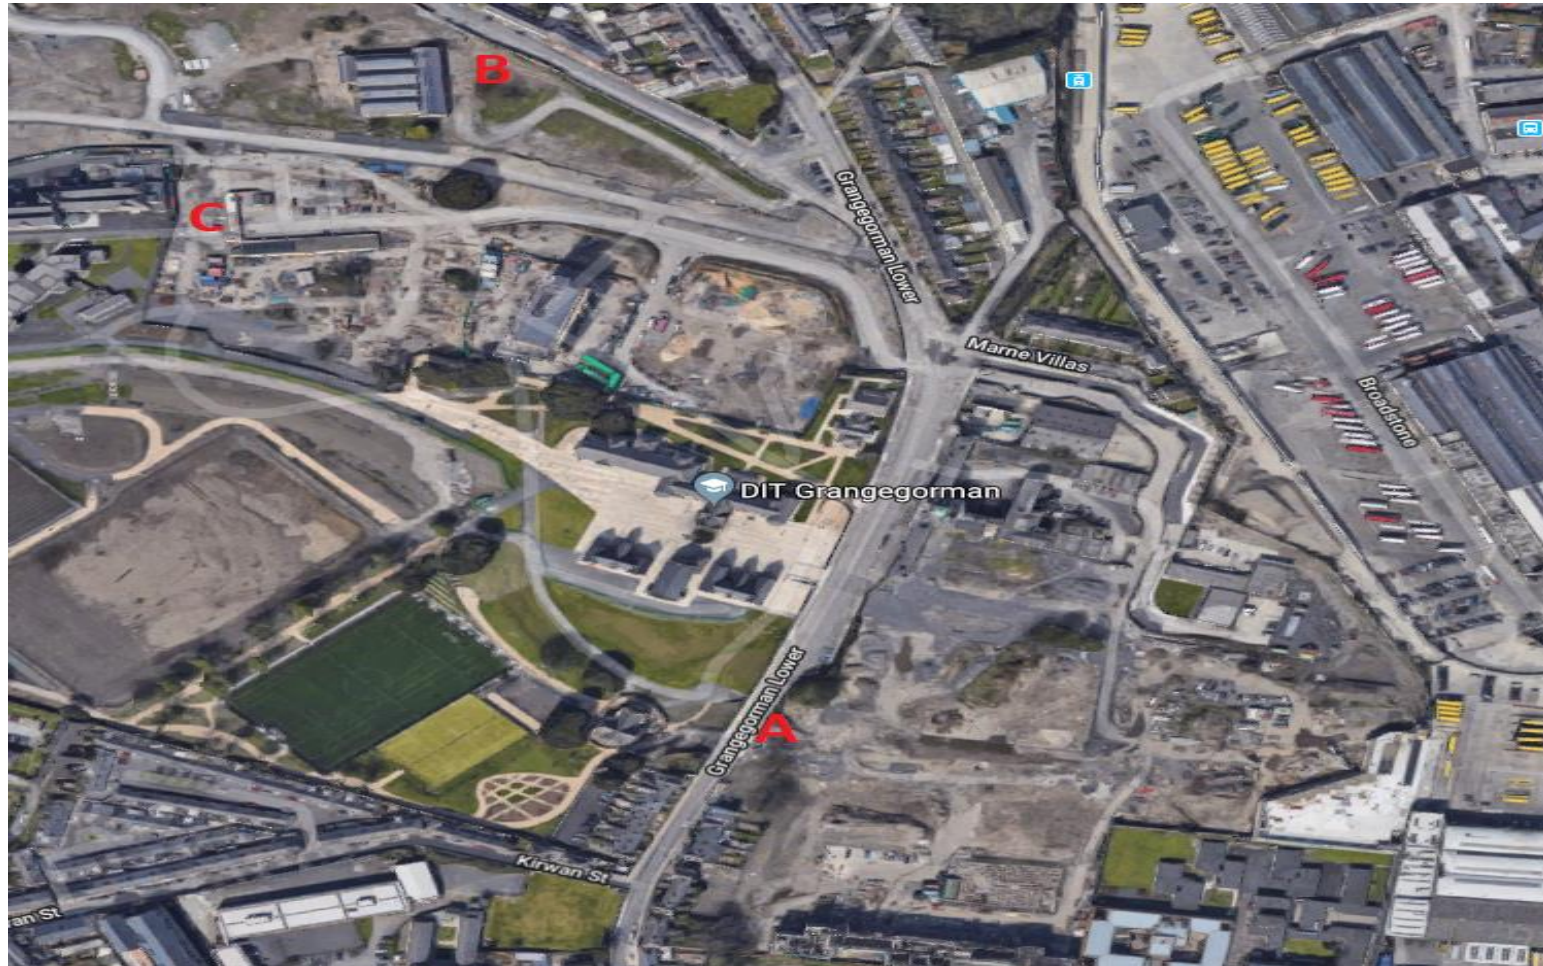
Figure 1: Dust Monitoring Locations, A B and C.

This report presents the results of dust monitoring at 3 locations, Location A; East Quad West Boundary Wall, Location B; Grangegorman Upper East Boundary Wall, and Location C; Grangegorman Upper North Boundary wall from 31st May to 28th June 2019. The locations are illustrated in Figure 1.

The dust gauges were set up at the location selected at positions A B and C. The locations are shown in Figure 1. The gauges were erected such that the containers were 1.8m above the ground surface and free from any obstruction. The containers were exposed from 31st May to 28th June 2019.
